## PRE-DRYWALL INSPECTION

123 Sample Street, Demo City, ST 12345

6/22/2026 12:38AM

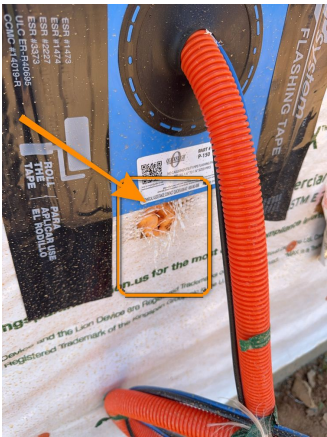
3.24 Ripped/Hole In House Rap

Rips and/or holes were observed in the house wrap at the exterior wall areas inspected. This condition can reduce the effectiveness of the weather-resistive barrier and may allow moisture intrusion behind the exterior cladding. Moisture entry in these areas could contribute to concealed deterioration of wall components over time. A qualified licensed contractor should evaluate and repair the damaged house wrap as needed.

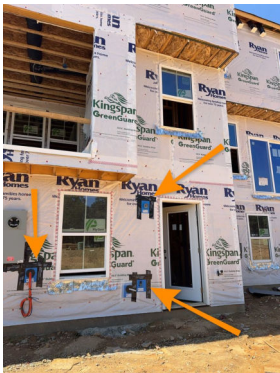
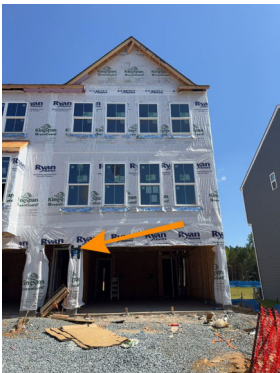
3.25 Improper Zip Tape Overlap

**Improper Zip Tape Overlap** was observed at the weather barrier house-wrap. The tape appeared to be installed with incorrect overlapping at seams, which can reduce the effectiveness of the water and air barrier and may allow moisture intrusion into the wall assembly. This condition may contribute to concealed deterioration or reduced energy performance over time. A qualified licensed contractor familiar with this system should evaluate and correct the tape installation as needed.

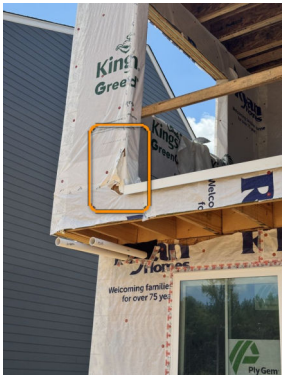
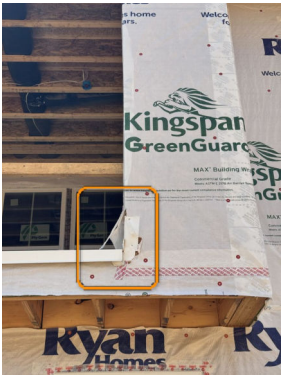
3.26 Torn House Wrap At Balcony Corners

**Requires Attention:** The house wrap was observed torn on both sides of the balcony where it meets the second-floor balcony edge corners. This condition can allow water intrusion behind the exterior wall covering and may contribute to concealed moisture damage over time. A qualified licensed contractor should evaluate and repair the weather-resistive barrier and associated flashing details as needed to help reduce the potential for moisture intrusion.

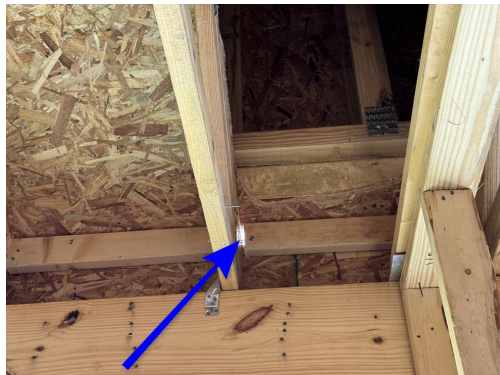
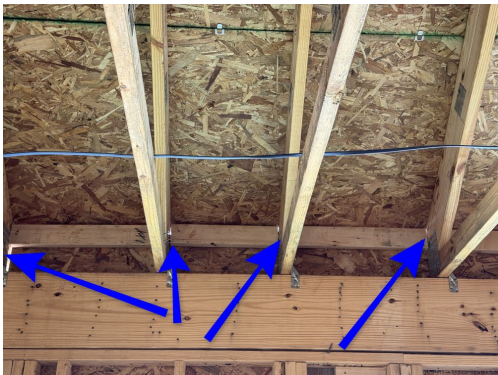
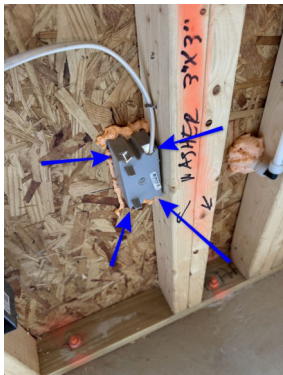
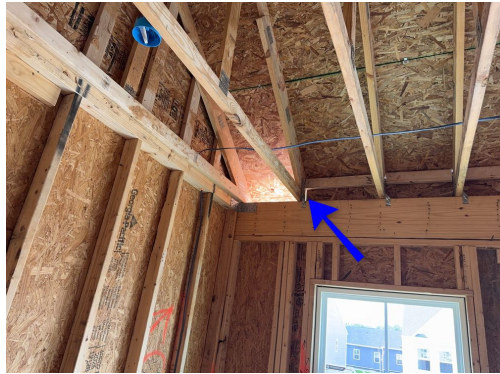
3.27 Gaps Could use Sealant

Visible gaps and failed sealant were observed at portions of the exterior siding and trim. Open gaps may allow moisture intrusion and pest entry behind the exterior cladding over time. The builder should seal the affected areas as necessary and evaluate the exterior for additional gaps requiring repair.

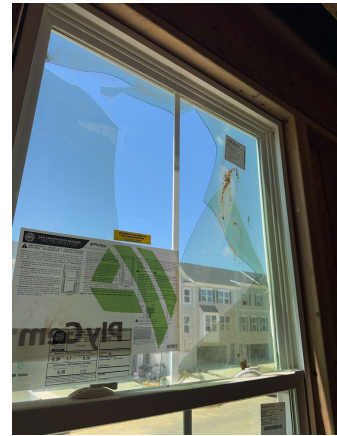
### 3.28 Cracked or Damaged Window Pane

A cracked or damaged window pane was observed at the time of inspection. This condition can allow water intrusion, air leakage, and further deterioration of the window assembly, and broken glass may present a safety concern. The affected pane should be evaluated and repaired or replaced as needed by a qualified licensed window contractor or glass specialist.

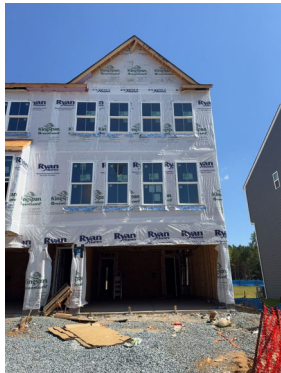
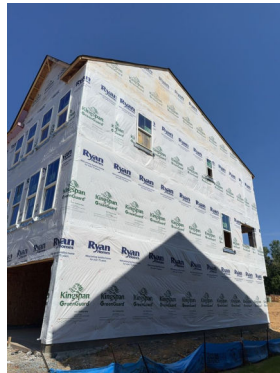
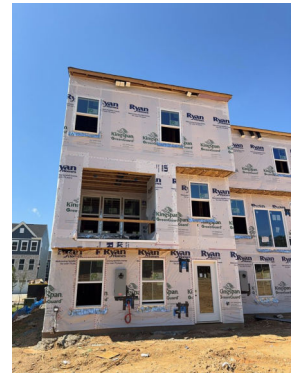
### 3.29 No Window Screens Installed

Window screens were not installed at the accessible windows at the time of this pre-drywall inspection. Screens are commonly installed during the final stages of construction and were not available for evaluation. No determination regarding the presence, condition, or operation of window screens could be made at the time of inspection. Verification of screen installation is recommended during the final inspection prior to closing.

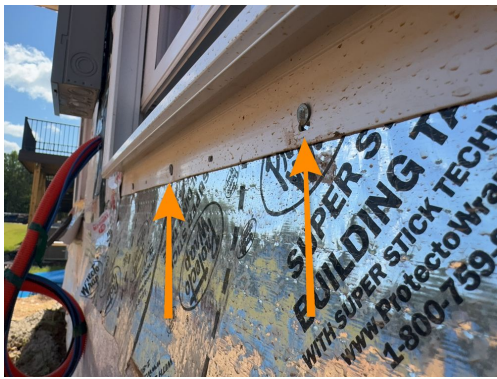
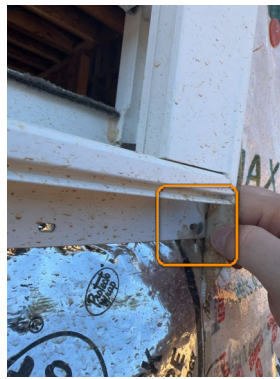
### 3.30 Improper Nail Fin Fastening

The window manufacturer requires fasteners to be installed through the provided nail fin holes; however, visible fasteners were observed driven through the vinyl adjacent to those holes. Although cracking of the vinyl was not observed at the time of inspection, this installation method is not consistent with the manufacturer's requirements and may contribute to stress, distortion, or moisture-related issues over time. A qualified licensed window installer or contractor should evaluate the affected windows and correct as needed in accordance with the manufacturer's installation instructions.

Proper placement, but underdriven fastener.

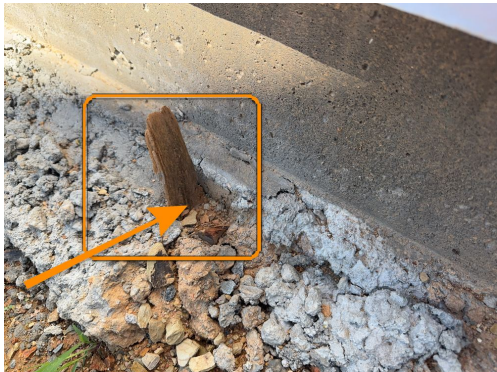
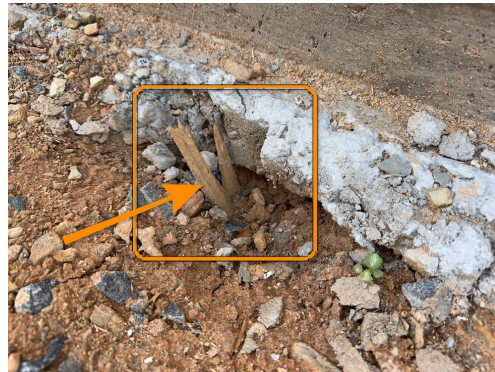
### 3.31 Remaining Wood Form Material

Partial wood form material was observed remaining adjacent to the foundation wall. Embedded wood can retain moisture and may contribute to deterioration or interfere with proper grading and drainage at the foundation area. This condition should be addressed to help reduce the potential for moisture-related damage. A qualified licensed contractor or the builder should remove the remaining wood debris and repair the affected area as needed.

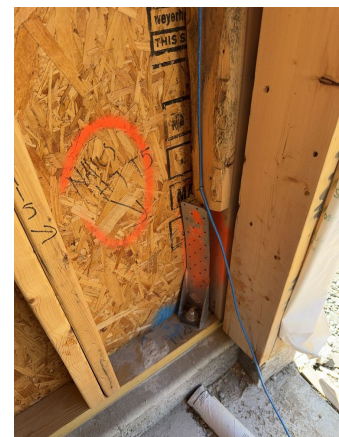
### 3.32 Unsecured Simpson HTT5 Hold Down

The Simpson HTT5 hold down at the exterior wall was observed not to be secured with the required fasteners. This condition may reduce the intended connection between the wall framing and foundation and could affect the wall's resistance to uplift or lateral movement. A qualified licensed contractor should evaluate the installation and secure the hold down with appropriate fasteners as needed. Correction is advised to help restore the intended structural connection.

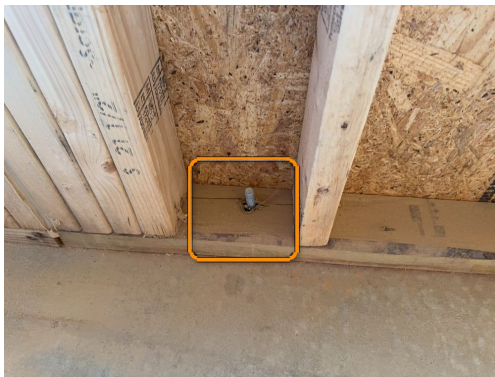
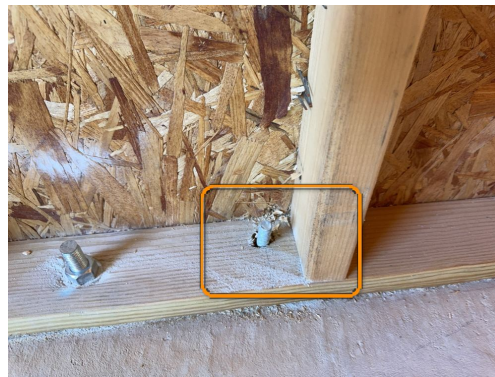
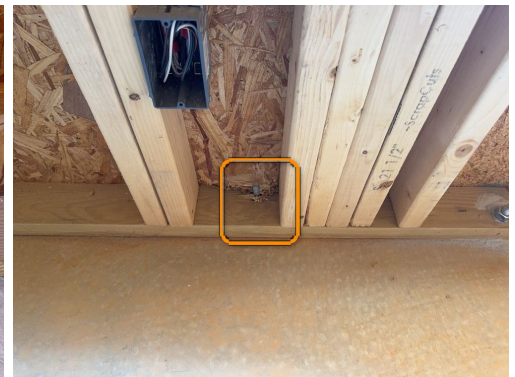
### 3.33 Missing Anchor Hardware

Washers and bolts were missing at visible foundation anchor locations. This condition can reduce the connection between the framing and foundation and may allow movement during wind or other structural loading. The installation observed is not consistent with modern building standards. A qualified licensed contractor should evaluate and install the missing washers and bolts, and correct as needed.

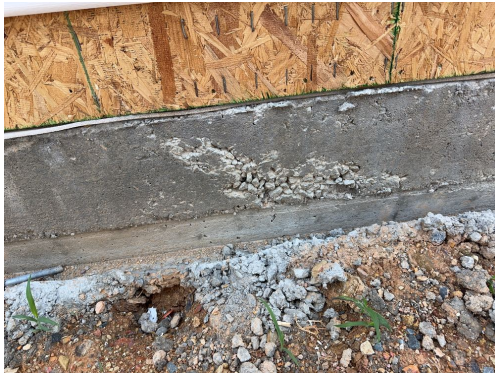
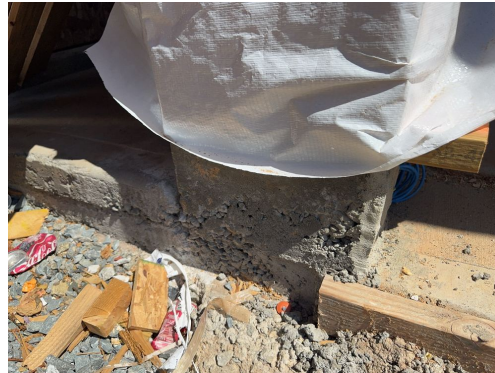
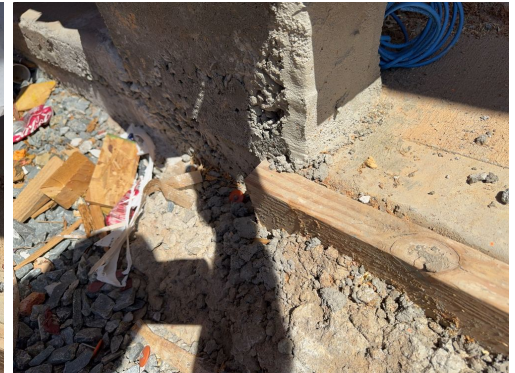
### 3.34 Honeycombing Foundation Walls

Honeycombing was observed on the exterior surfaces of the perimeter foundation walls. This condition indicates areas where the concrete did not consolidate properly and may allow increased moisture intrusion or localized deterioration over time. The full extent of the condition was not determined during this visual inspection. A qualified licensed foundation contractor should evaluate and correct as needed.

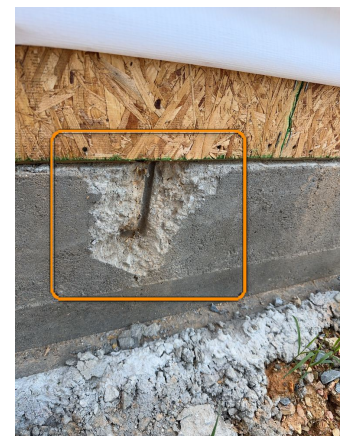
### 3.35 Missing Anchor Bolt Location

A marked anchor bolt location was observed without an installed anchor bolt, and localized concrete spalling was present at the adjacent foundation wall. Anchor bolts are intended to secure the framing to the foundation, and this condition may reduce the effectiveness of the connection and could allow movement under load. The visible concrete damage may also affect the performance of the anchorage at this area. A qualified licensed contractor or the builder should evaluate this location, verify compliance with the approved construction documents, and correct as needed.

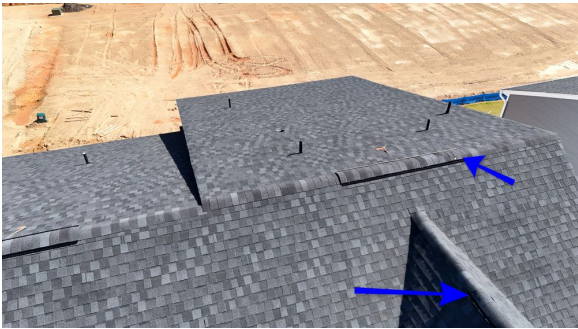
4.18 Exposed Nail Heads Noted in Some Areas of Roof Covering

Exposed fastener heads were observed on the roof covering. Unprotected fasteners may be more susceptible to corrosion and moisture intrusion over time. Application of an approved roofing sealant to the exposed fastener heads is recommended as a routine maintenance item to help protect the fasteners and reduce the potential for future concerns.

Fasteners (nails) exposed

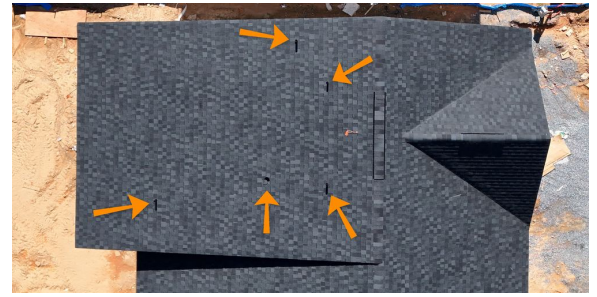
#### 4.19 Missing Roof Penetration Flashings/Boots

**Requires Attention:** Roof penetrations were observed with missing boots and/or flashings at the time of inspection, which is common during this phase of construction. These components are important to help seal the roof covering and reduce the potential for water intrusion at penetrations. If not properly installed before completion, leakage and related moisture damage could occur. A qualified licensed roofing contractor or builder should install the missing boots and flashings and verify proper completion at the final stage.

Missing Penetration Boots/flashings

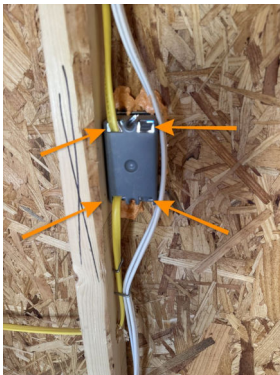
**Requires Attention:** Openings were observed around plumbing penetrations and electrical outlets at the garage wall/ceiling separation adjacent to the living space. These areas were not air tight at the time of inspection, which can allow the movement of air, fumes, moisture, and in some cases smoke between the garage and interior living areas. This condition is not consistent with a proper separation between the garage and the home and may reduce the effectiveness of the barrier. A qualified licensed contractor should evaluate and seal these penetrations with appropriate materials and correct as needed.

Outlets not Air tight

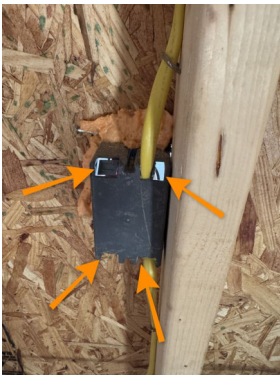
Outlets not Air tight

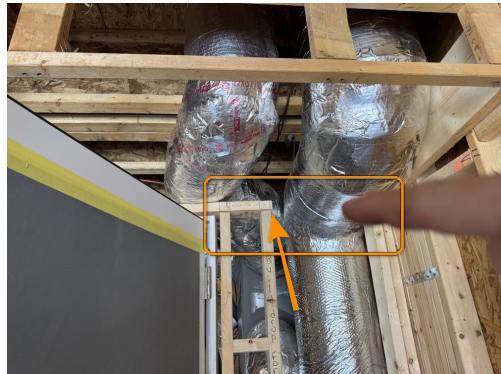
**Requires Attention:** Framing at the garage wall into the utility room was observed to be cut, and portions of the framing were not anchored to the foundation. This condition may reduce the intended structural support and attachment of the wall assembly and could allow movement or further deterioration over time. Altered or improperly secured framing at this location may also affect the separation between the garage and interior areas. A qualified licensed contractor should evaluate and correct as needed.

Utility room wall framing cut

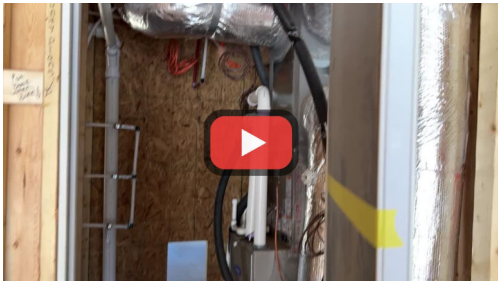
Utility room wall framing cut

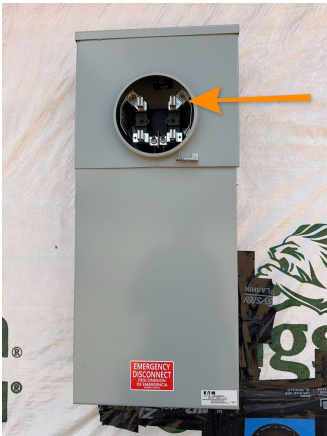
6.26 Service Lateral Not Yet Installed

The electrical service lateral had not been installed or run to the panel box at the time of inspection. This condition is typical during this phase of new construction and limited evaluation of the permanent electrical service equipment. Once installation is complete, the system should be evaluated as part of the normal construction process to confirm proper completion and operation. A qualified licensed electrical contractor should complete and verify the installation as needed.

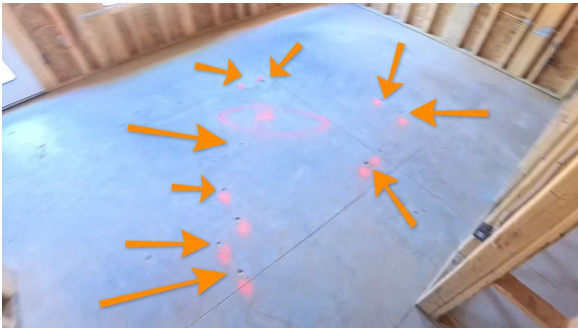
9.32 Chipped Concrete Floor

**Requires Attention:** Chips and areas of missing concrete were observed at the interior foundation floor in the living/sitting room. This condition may create an uneven walking surface and can allow further surface deterioration over time. The damaged areas should be evaluated and repaired as needed to help restore a more even and serviceable floor surface. A qualified licensed contractor should evaluate and correct as needed.

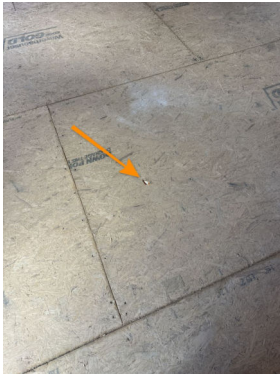
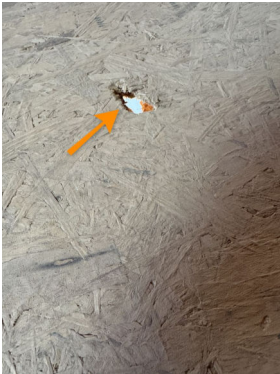
9.33 Hole in Subflooring

A hole larger than approximately 1 inch in diameter was observed in the second-floor subflooring. This condition can weaken the affected floor area and may allow movement, further damage, or a potential safety concern if not corrected. The full extent of the condition was not determined during this visual inspection. A qualified licensed contractor should evaluate and repair the subflooring as needed.

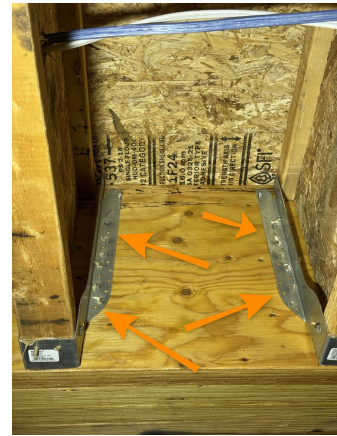
### 9.34 Missing Simpson Tie Fasteners

Missing fasteners were observed at Simpson ties/metal hangers in the floor framing and floor to floor strapping. This condition can reduce the intended connection strength of the supported framing members and may allow movement or diminished load transfer. The full extent of concealed fastening was not visible at finished areas. A qualified licensed contractor should evaluate and install the proper manufacturer-approved fasteners as needed.

Missing fasteners (nails)

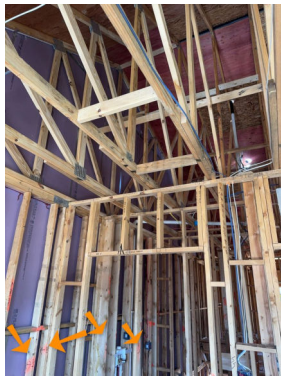
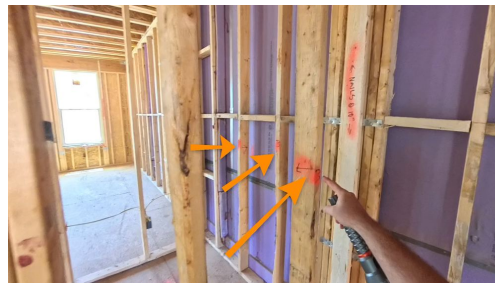
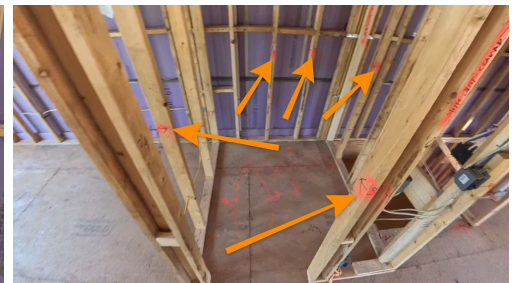
### 9.35 Bowed stud

Multiple bowed wall studs were observed throughout the home at the time of inspection. The affected studs had been identified and marked by the builder prior to the inspection. Bowed framing members can affect the alignment and finish quality of wall surfaces. The builder should repair or replace the affected framing members as necessary prior to installation of drywall.

All bowed 2x4's were marked with a 'B' & arrow of direction it needs to move.

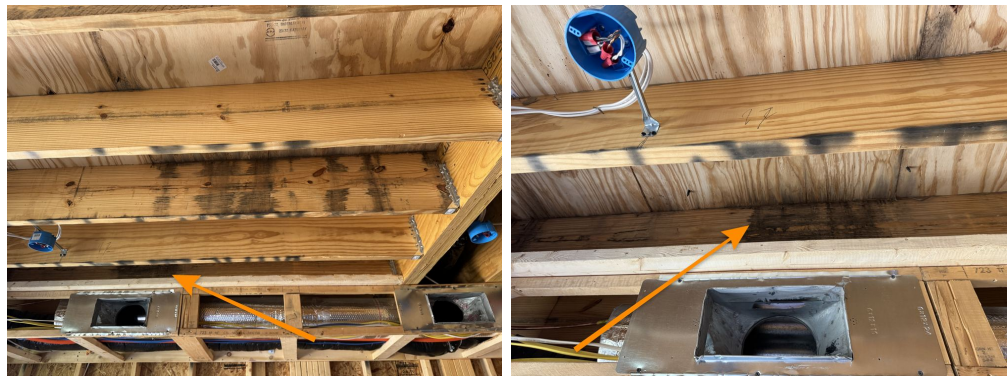
12.1 Mold Like Substance Present on Joists  
Fungal Growth

A mold-like substance was observed on portions of the second-floor joists as viewed from the first-floor living room during this pre-drywall inspection. Organic growth can develop when building materials are exposed to elevated moisture levels during construction. The source of moisture and the extent of the affected materials could not be determined during the inspection. The builder should evaluate the affected areas and clean, treat, or replace materials as necessary prior to installation of insulation and drywall.
