## PRE-DRYWALL INSPECTION

123 Sample Street, Demo City, ST 12345

6/22/2026 12:38AM

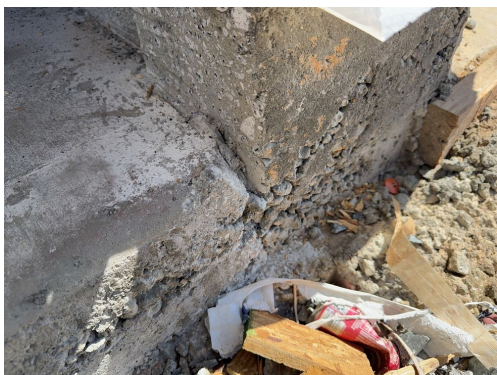
Honeycombing

Honeycombing to the right of garage of foundation wall

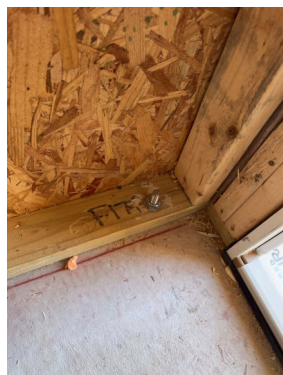
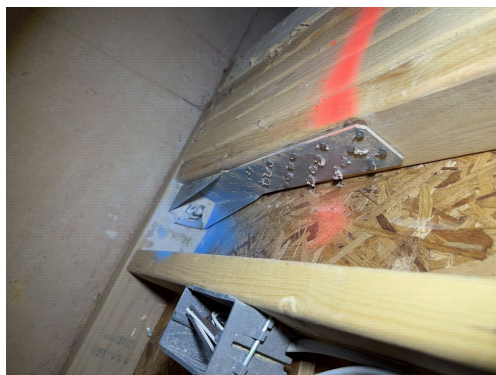
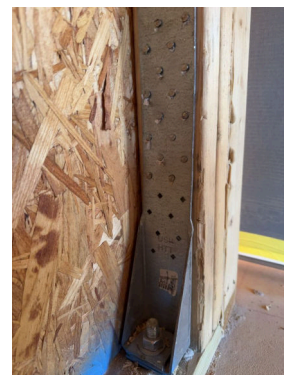
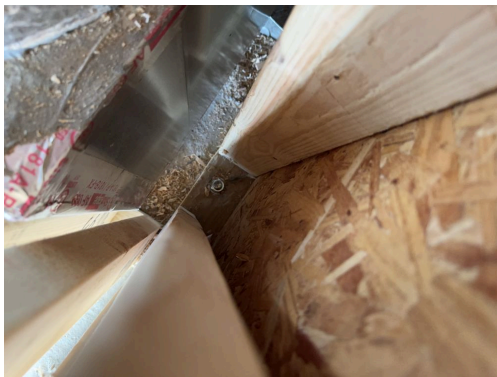
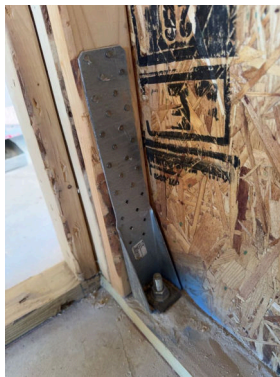
**Location:** 1st Floor

### 3.23 Anchor Bolts / Tie Downs: Missing anchor bolts observed, Installed where visible

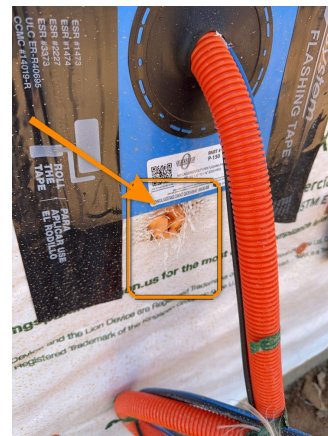
### 3.24 Ripped/Hole In House Rap

Rips and/or holes were observed in the house wrap at the exterior wall areas inspected. This condition can reduce the effectiveness of the weather-resistive barrier and may allow moisture intrusion behind the exterior cladding. Moisture entry in these areas could contribute to concealed deterioration of wall components over time. A qualified licensed contractor should evaluate and repair the damaged house wrap as needed.

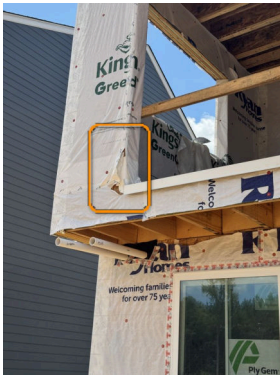
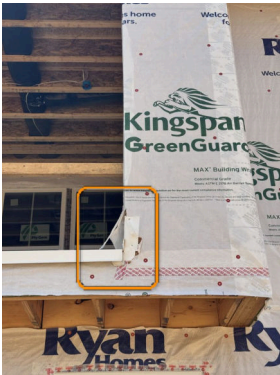
Location: Balcony, 2nd Floor

**Requires Attention:** The house wrap was observed torn on both sides of the balcony where it meets the second-floor balcony edge corners. This condition can allow water intrusion behind the exterior wall covering and may contribute to concealed moisture damage over time. A qualified licensed contractor should evaluate and repair the weather-resistive barrier and associated flashing details as needed to help reduce the potential for moisture intrusion.

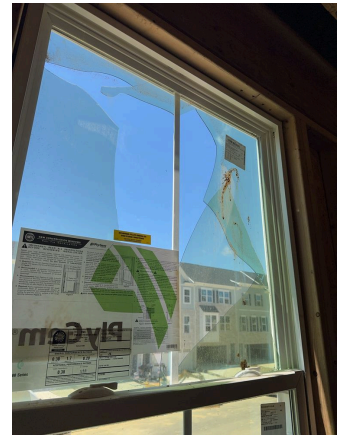
### 3.28 Cracked or Damaged Window Pane

A cracked or damaged window pane was observed at the time of inspection. This condition can allow water intrusion, air leakage, and further deterioration of the window assembly, and broken glass may present a safety concern. The affected pane should be evaluated and repaired or replaced as needed by a qualified licensed window contractor or glass specialist.

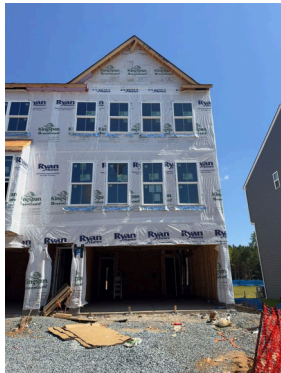
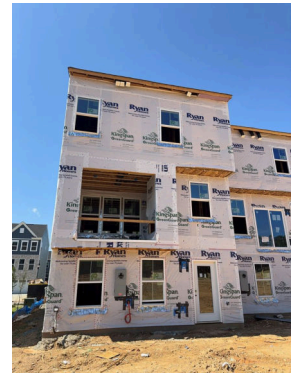
**Location:** All Windows

### 3.29 No Window Screens Installed

Window screens were not installed at the accessible windows at the time of this pre-drywall inspection. Screens are commonly installed during the final stages of construction and were not available for evaluation. No determination regarding the presence, condition, or operation of window screens could be made at the time of inspection. Verification of screen installation is recommended during the final inspection prior to closing.

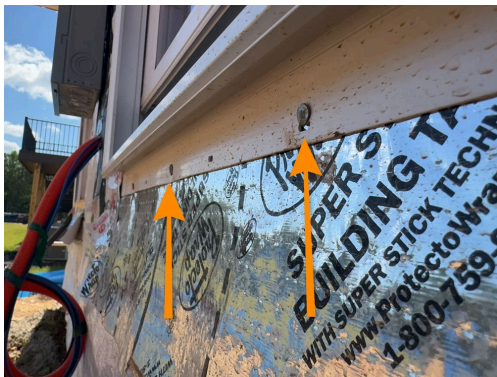
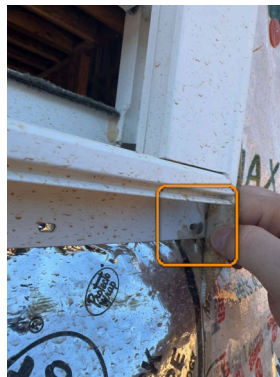
**Location:** Front of Home, Right of Home, Back of Home

### 3.30 Improper Nail Fin Fastening

The window manufacturer requires fasteners to be installed through the provided nail fin holes; however, visible fasteners were observed driven through the vinyl adjacent to those holes. Although cracking of the vinyl was not observed at the time of inspection, this installation method is not consistent with the manufacturer's requirements and may contribute to stress, distortion, or moisture-related issues over time. A qualified licensed window installer or contractor should evaluate the affected windows and correct as needed in accordance with the manufacturer's installation instructions.

Proper placement, but underdriven fastener.

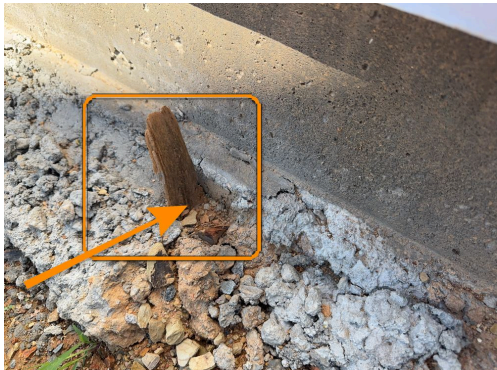
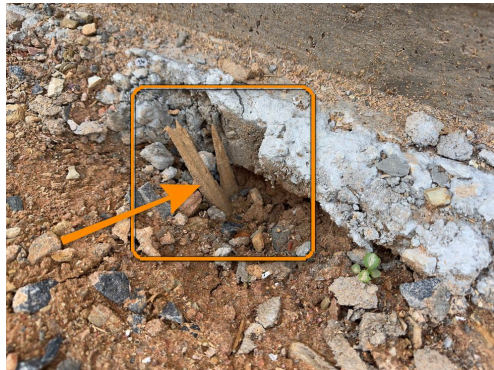
### 3.31 Remaining Wood Form Material

Partial wood form material was observed remaining adjacent to the foundation wall. Embedded wood can retain moisture and may contribute to deterioration or interfere with proper grading and drainage at the foundation area. This condition should be addressed to help reduce the potential for moisture-related damage. A qualified licensed contractor or the builder should remove the remaining wood debris and repair the affected area as needed.

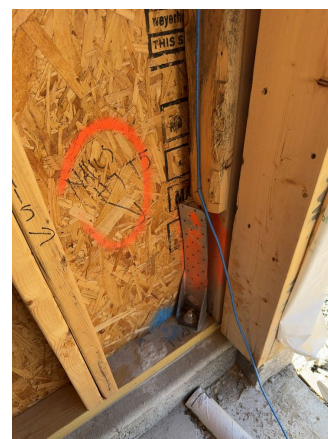
### 3.32 Unsecured Simpson HTT5 Hold Down

The Simpson HTT5 hold down at the exterior wall was observed not to be secured with the required fasteners. This condition may reduce the intended connection between the wall framing and foundation and could affect the wall's resistance to uplift or lateral movement. A qualified licensed contractor should evaluate the installation and secure the hold down with appropriate fasteners as needed. Correction is advised to help restore the intended structural connection.

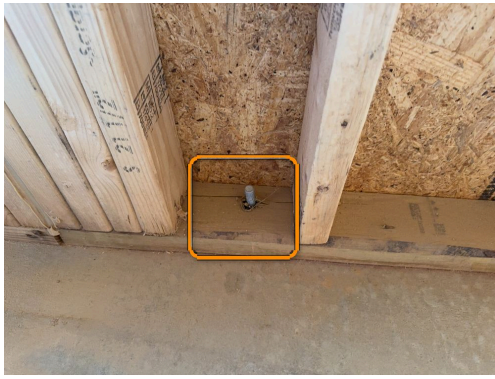
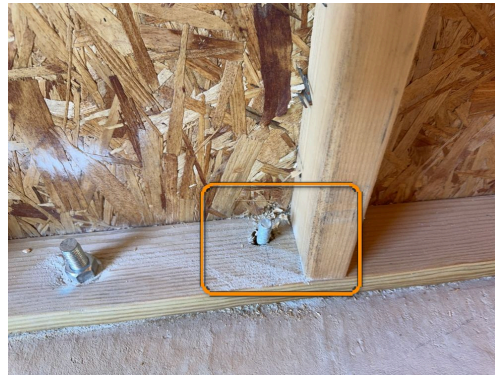
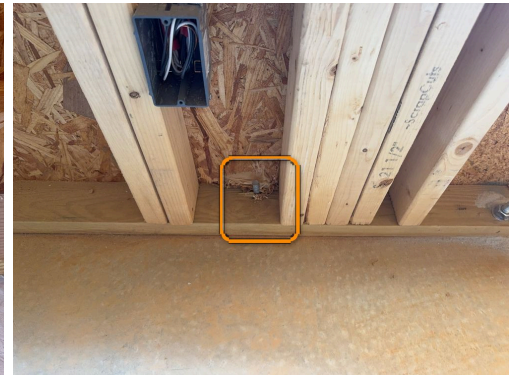
**Location:** 1st floor perimeter

### 3.33 Missing Anchor Hardware

Washers and bolts were missing at visible foundation anchor locations. This condition can reduce the connection between the framing and foundation and may allow movement during wind or other structural loading. The installation observed is not consistent with modern building standards. A qualified licensed contractor should evaluate and install the missing washers and bolts, and correct as needed.

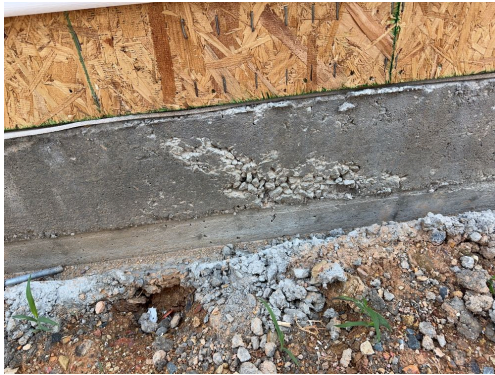
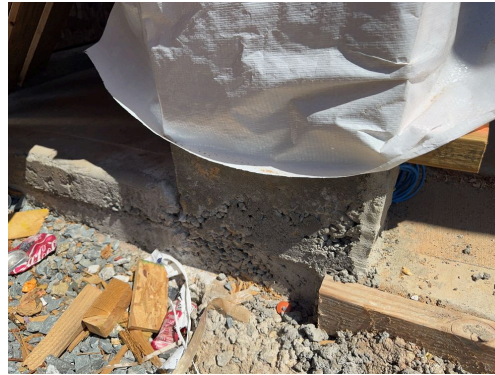
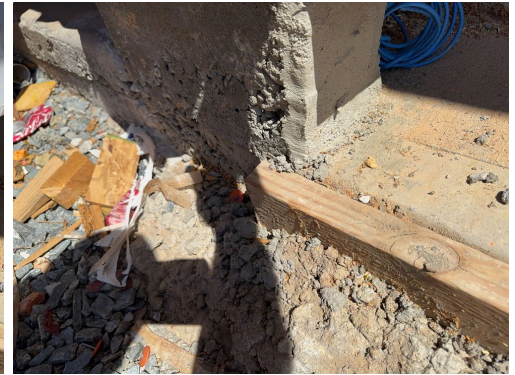
### 3.34 Honeycombing Foundation Walls

Honeycombing was observed on the exterior surfaces of the perimeter foundation walls. This condition indicates areas where the concrete did not consolidate properly and may allow increased moisture intrusion or localized deterioration over time. The full extent of the condition was not determined during this visual inspection. A qualified licensed foundation contractor should evaluate and correct as needed.

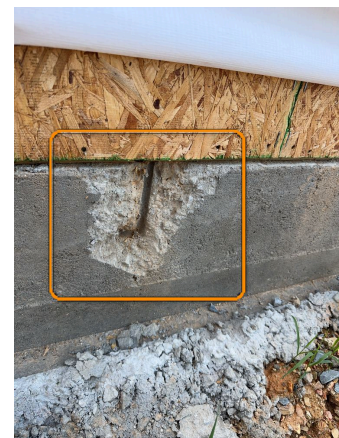
**Location:** Right of Home

### 3.35 Missing Anchor Bolt Location

A marked anchor bolt location was observed without an installed anchor bolt, and localized concrete spalling was present at the adjacent foundation wall. Anchor bolts are intended to secure the framing to the foundation, and this condition may reduce the effectiveness of the connection and could allow movement under load. The visible concrete damage may also affect the performance of the anchorage at this area. A qualified licensed contractor or the builder should evaluate this location, verify compliance with the approved construction documents, and correct as needed.

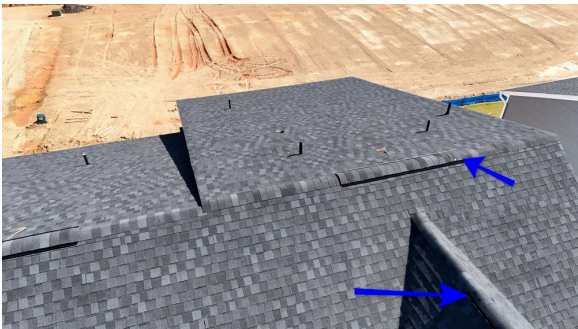
4.18 Exposed Nail Heads Noted in Some Areas of Roof Covering

Exposed fastener heads were observed on the roof covering. Unprotected fasteners may be more susceptible to corrosion and moisture intrusion over time. Application of an approved roofing sealant to the exposed fastener heads is recommended as a routine maintenance item to help protect the fasteners and reduce the potential for future concerns.

Fasteners (nails) exposed

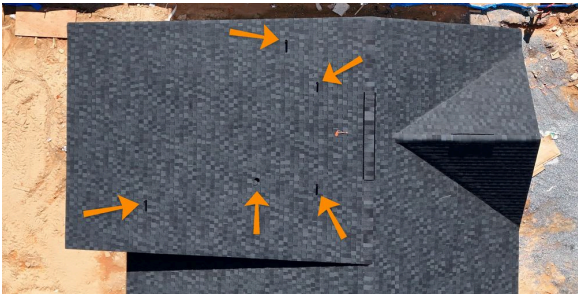
4.19 Missing Roof Penetration Flashings/Boots

Requires Attention: Roof penetrations were observed with missing boots and/or flashings at the time of inspection, which is common during this phase of construction. These components are important to help seal the roof covering and reduce the potential for water intrusion at penetrations. If not properly installed before completion, leakage and related moisture damage could occur. A qualified licensed roofing contractor or builder should install the missing boots and flashings and verify proper completion at the final stage.

Missing Penetration Boots/flashings

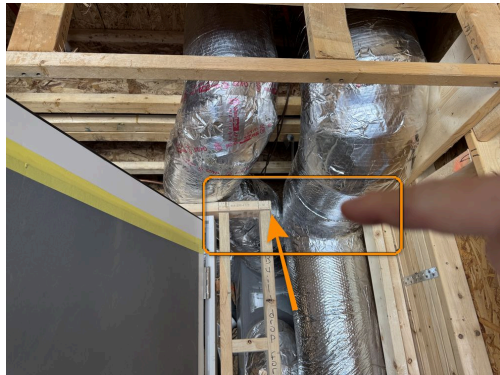
**Location:** Garage

**Requires Attention:** Framing at the garage wall into the utility room was observed to be cut, and portions of the framing were not anchored to the foundation. This condition may reduce the intended structural support and attachment of the wall assembly and could allow movement or further deterioration over time. Altered or improperly secured framing at this location may also affect the separation between the garage and interior areas. A qualified licensed contractor should evaluate and correct as needed.

Utility room wall framing cut

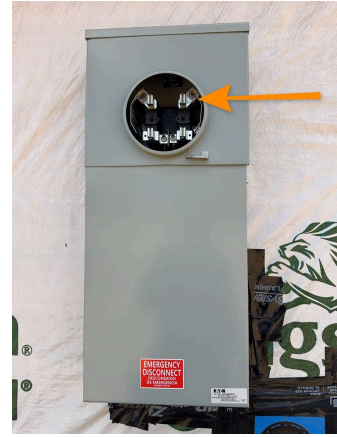
The electrical service lateral had not been installed or run to the panel box at the time of inspection. This condition is typical during this phase of new construction and limited evaluation of the permanent electrical service equipment. Once installation is complete, the system should be evaluated as part of the normal construction process to confirm proper completion and operation. A qualified licensed electrical contractor should complete and verify the installation as needed.

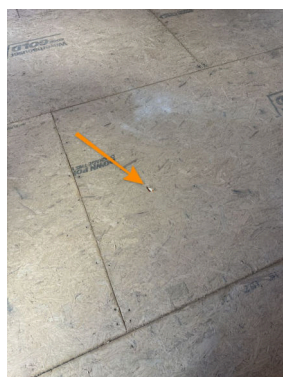
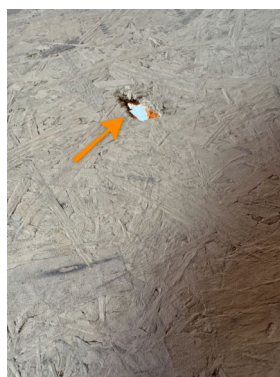
**Location:** 2nd Floor

A hole larger than approximately 1 inch in diameter was observed in the second-floor subflooring. This condition can weaken the affected floor area and may allow movement, further damage, or a potential safety concern if not corrected. The full extent of the condition was not determined during this visual inspection. A qualified licensed contractor should evaluate and repair the subflooring as needed.

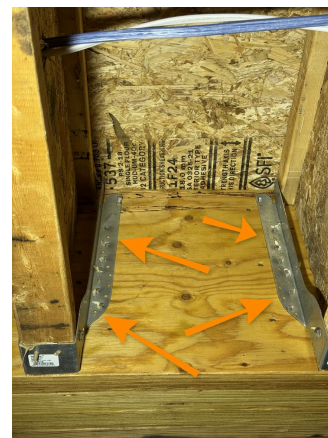
### 9.34 Missing Simpson Tie Fasteners

Missing fasteners were observed at Simpson ties/metal hangers in the floor framing and floor to floor strapping. This condition can reduce the intended connection strength of the supported framing members and may allow movement or diminished load transfer. The full extent of concealed fastening was not visible at finished areas. A qualified licensed contractor should evaluate and install the proper manufacturer-approved fasteners as needed.

Missing fasteners (nails)

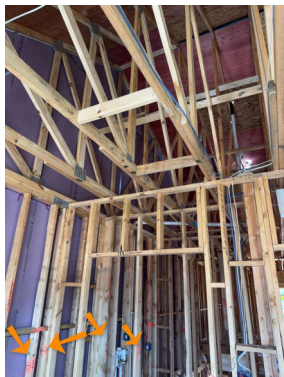
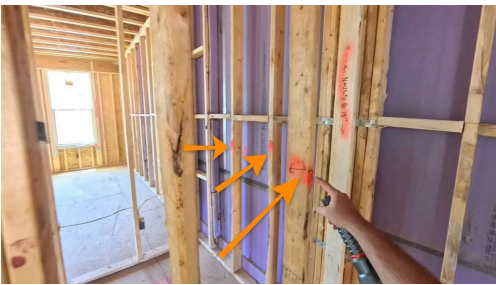
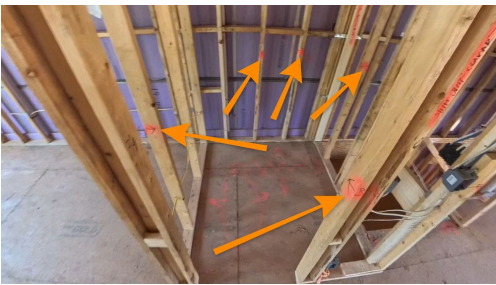
### 9.35 Bowed stud

Multiple bowed wall studs were observed throughout the home at the time of inspection. The affected studs had been identified and marked by the builder prior to the inspection. Bowed framing members can affect the alignment and finish quality of wall surfaces. The builder should repair or replace the affected framing members as necessary prior to installation of drywall.

All bowed 2x4's were marked with a 'B' & arrow of direction it needs to move.

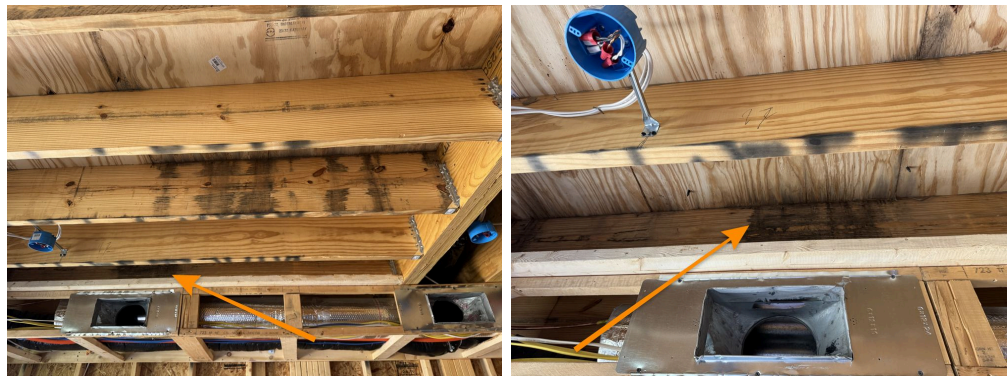
A mold-like substance was observed on portions of the second-floor joists as viewed from the first-floor living room during this pre-drywall inspection. Organic growth can develop when building materials are exposed to elevated moisture levels during construction. The source of moisture and the extent of the affected materials could not be determined during the inspection. The builder should evaluate the affected areas and clean, treat, or replace materials as necessary prior to installation of insulation and drywall.

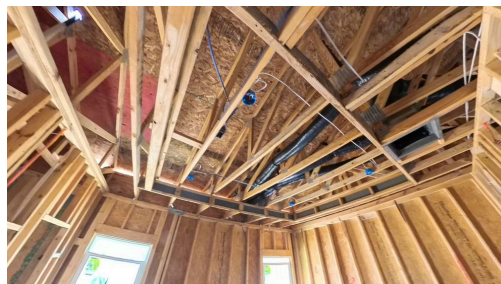
Master bedroom ceiling

No central ceiling light/fan bracket was observed at the noted location. Installing a fan-rated, weight-supported bracket with wiring run to a wall switch would provide support for a future ceiling fan or light fixture. This is considered an upgrade item rather than a defect, but adding the proper support and wiring can improve convenience and future installation options. A qualified licensed electrical contractor should evaluate and install the appropriate bracket and wiring as needed.
