## PRE-DRYWALL INSPECTION

123 Sample Street, Demo City, ST 12345

6/22/2026 12:38AM

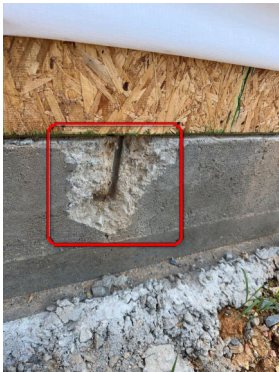
3.34 - Honeycombing Foundation Walls
-

**3.22 Foundation Walls:** Honeycombing observed

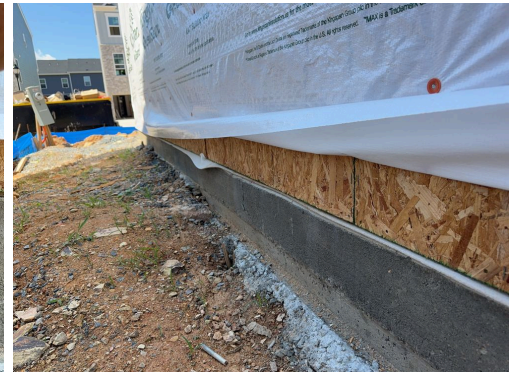
White foam sill sealer ripped where

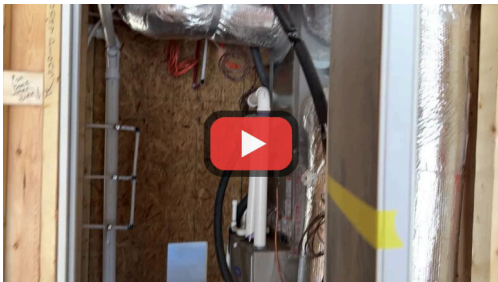
**Requires Attention:** Framing at the garage wall into the utility room was observed to be cut, and portions of the framing were not anchored to the foundation. This condition may reduce the intended structural support and attachment of the wall assembly and could allow movement or further deterioration over time. Altered or improperly secured framing at this location may also affect the separation between the garage and interior areas. A qualified licensed contractor should evaluate and correct as needed.

Garage  
Utility room wall framing cut

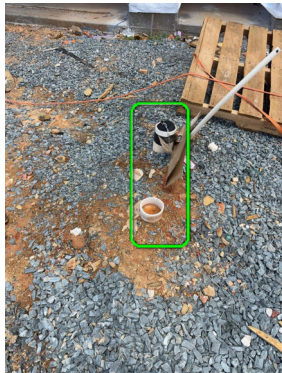
driveway drain cleanouts

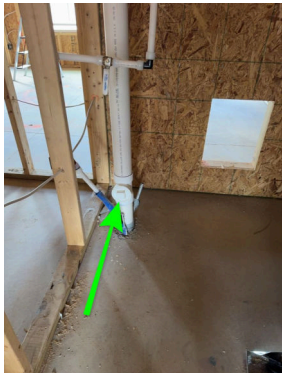
Utility room cleanout

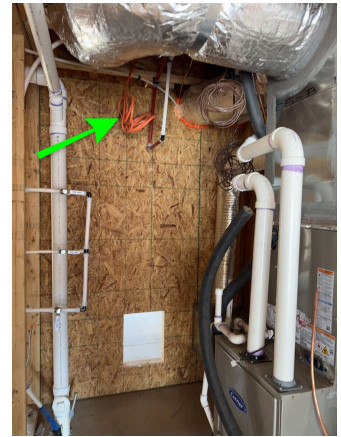
Electrical for planned water heater

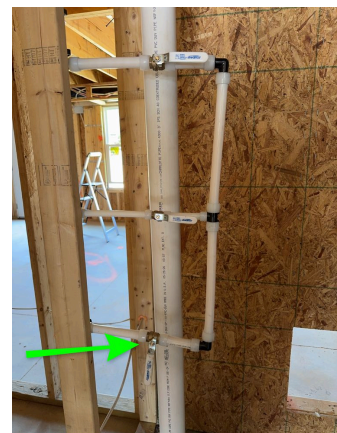
The main water shut off valve is located in the garage.

Main Water Shutoff
