## PRE-DRYWALL INSPECTION

123 Sample Street, Demo City, ST 12345

6/22/2026 12:38AM

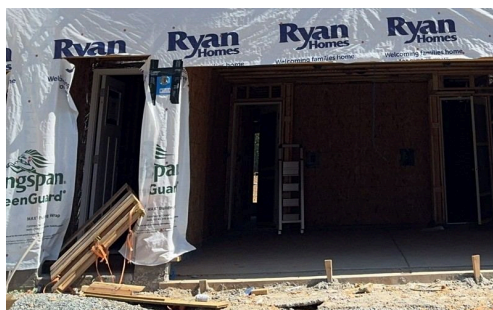
### 3.8 Recessed exit doors

door frame and jambs. While the door is designed for exterior use and no deficiencies were observed at the time of inspection, this type of installation is more susceptible to moisture-related deterioration over time. Periodic monitoring and maintenance of the door, frame, and sealants is advised to help reduce the potential for future wood decay or moisture intrusion.

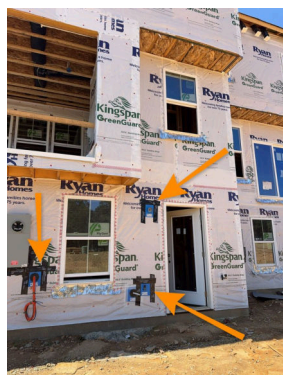
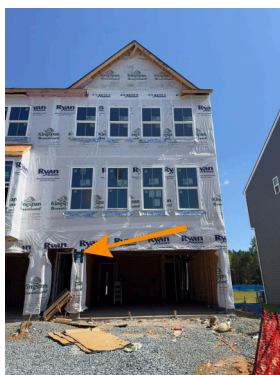
3.25 - Improper Zip Tape Overlap (Location: Back of Home)
-

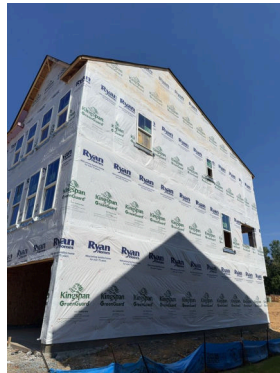
Window screens were not installed at the accessible windows at the time of this pre-drywall inspection. Screens are commonly installed during the final stages of construction and were not available for evaluation. No determination regarding the presence, condition, or operation of window screens could be made at the time of inspection. Verification of screen installation is recommended during the final inspection prior to closing.

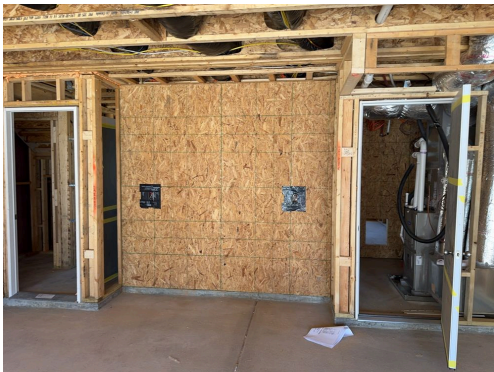
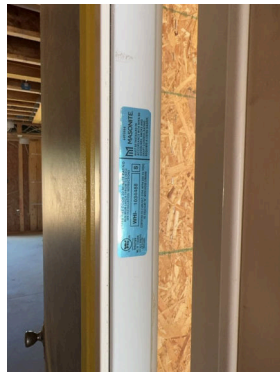
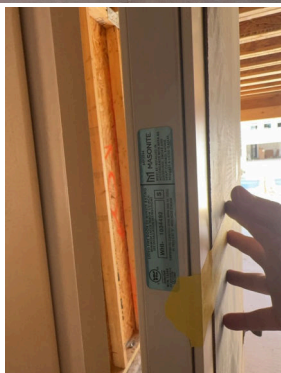
## 5.16 Fire Rated Self-Closing Doors

The door(s) between the garage and living space were observed to be fire-rated and equipped with self-closing hinges. This type of door assembly is intended to help slow the spread of fire and fumes from the garage into the home. The observed condition is consistent with a safety feature commonly installed at this location at the time of inspection.

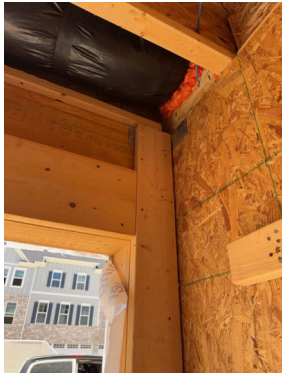
5.18 Garage Bearing Points, Not Visible

Requires Attention

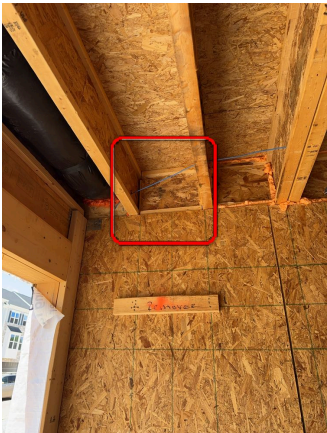
5.19 Missing Fire Blocking

Safety Concerns

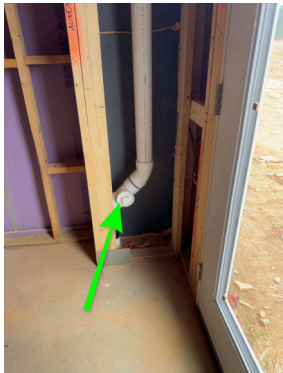
Back of home cleanout

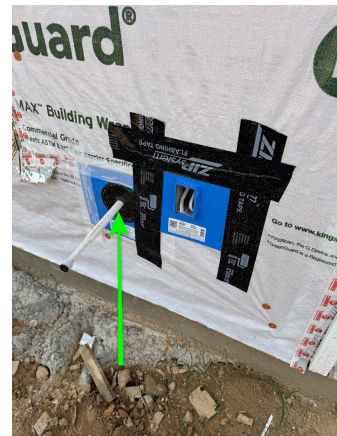
Hose bib ready

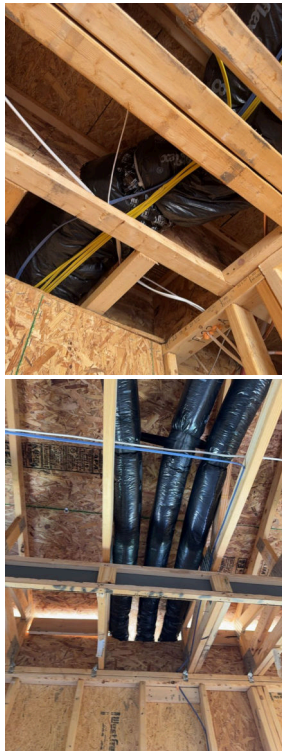
**8.10 Duct support present**  
HVAC Rough-In

**8.11 Refrigerant lines installed**  
HVAC Rough-In

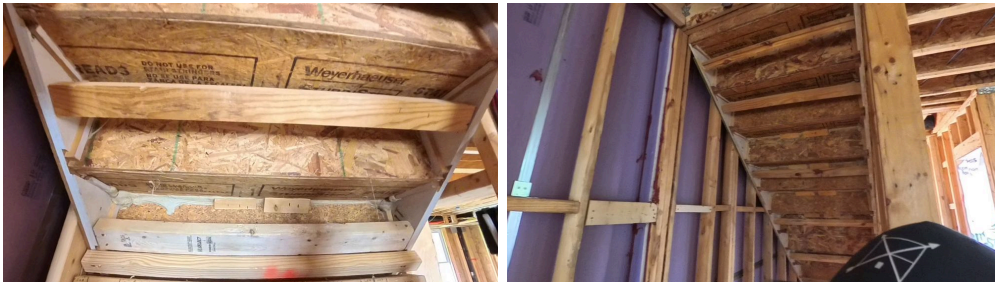
9.6 Stringers properly installed  
Steps, Stairways, Balconies and Railings

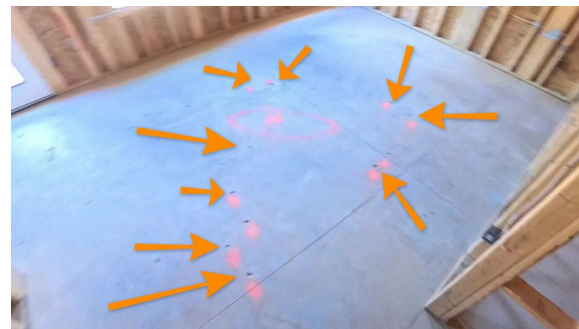
**Location:** Living Room

**Requires Attention:** Chips and areas of missing concrete were observed at the interior foundation floor in the living/sitting room. This condition may create an uneven walking surface and can allow further surface deterioration over time. The damaged areas should be evaluated and repaired as needed to help restore a more even and serviceable floor surface. A qualified licensed contractor should evaluate and correct as needed.

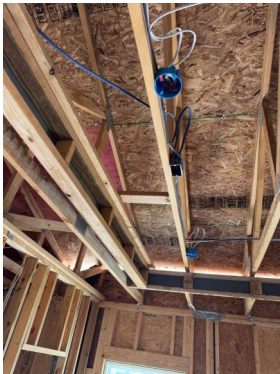
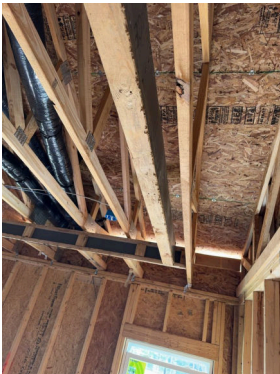
10.1 Attic Insulation: Not Installed Yet  
General

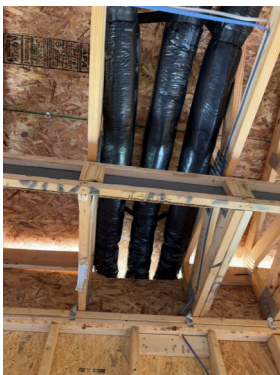
10.7 Exhaust Vent Present In Bathrooms  
Venting Systems (Kitchens, Baths and Laundry)
